SPECIFICATIONS

ASSEMBLY DRAWING

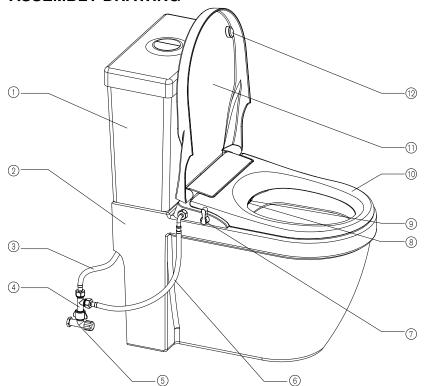
- 1. Cistern (not included)
- 2. Pan (not included)
- 3. Flexible hose
- 4. T shape adapter
- 5. Isolation Valve (not included)
- 6. Flexible Hose
- 7.Control Knob
- 8.Feminine wash nozzle
- 9.Posterior Wash nozzle
- 10. Seat rim
- 11. Seat cover
- 12. Buffer
